## 2021-2023 TOYOTA SIENNA AND VENZA CODELINK PROCEDURE

Note: This is a temporary workaround procedure. Instructions in this document will be included in the release of the 2024.0.1 software in November, 2023.

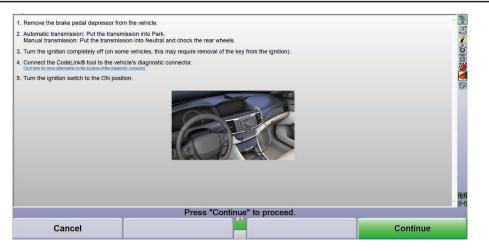
Figure 1.

Note: The following screen is missing instructions that the emergency brake must be released.

1. If retrying the procedure turn the vehicle off for 2 minutes before starting.

Note: The vehicle should be in "Ignition On" but not "Ready to Drive" mode or DTC's may result.

Note: If you are re-performing this procedure please ensure the vehicle has been powered off (Ignition off, interior and dash lights off, vehicle "asleep") for at least 2 minutes before starting this procedure. This may require you to remove the key from the vehicle and place it a few feet away.

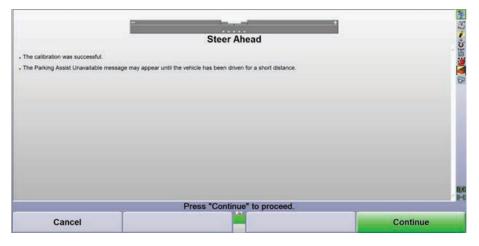
Figure 5.

5. Successful calibration screen will appear. Click Continue to proceed.
