## 2021-2023 TOYOTA SIENNA AND VENZA CODELINK PROCEDURE

Note: This is a temporary workaround procedure. Instructions in this document will be included in the release of the 2024.0.1 software in November, 2023.

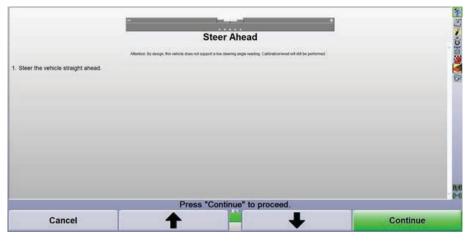
3. Switch the ignition off. Wait ten seconds. Turn the ignition switch to the ON position.

ue" to proceed.	EI M
		×.
or here an		0 • • • • • • • • • • •
2. Wait ten seconds. 3. Turn the ignition switch to the ON position.		
1. Switch the ignition off.		2
