## **Quick Check Drive**<sup>®</sup> **Inspection** Autonomous Alignment and Tread Depth for the Service Drive

# *Featuring Flightboard*<sup>™</sup> — *At-A-Glance touchless inspection results*

> PRELIMINARY Form 7632-TE-05, 11/19 To Supersede Form 7547-TE-05, 09/19

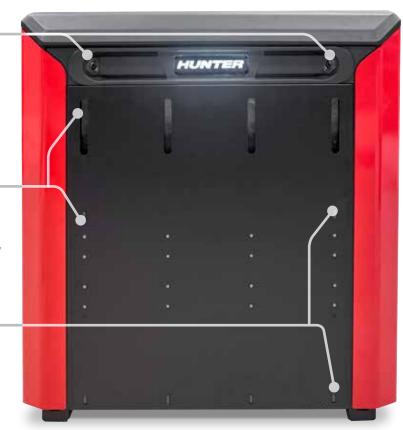
# **How It Works...** As the vehicle drives through, cameras measure distances to the tire to calculate total toe and individual camber.

Hunter's patented system acquires up to 16 results. Measurement outliers are removed and the other results are averaged to provide utmost accuracy.

#### 8 Cameras and \_ 32 Laser Sensors

- ✓ Accurately inspect camber and total toe
- 16 measurements taken to increase accuracy
- Repeatable results

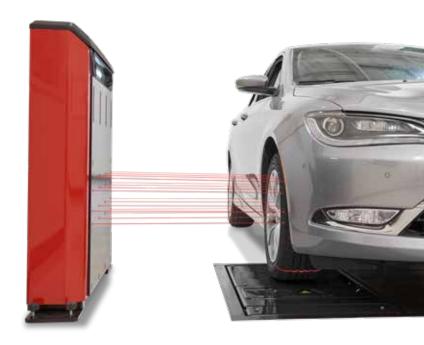
Accurate tread depth calculated for each groove.

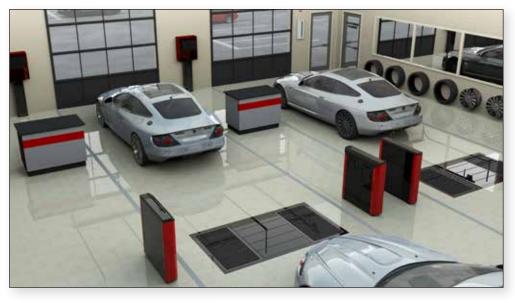
Flush-Mount Quick Tread Edge<sup>®</sup> (with alternate WU572 console)

- Smooth approach
- Zero obstructions
- ✓ Compatible with Quick Check Drive<sup>™</sup>
